MARYLAND PROFESSIONAL MOLD SERVICES LLC
POST OFFICE BOX 613
PASADENA, MARYLAND 21123-0613

Observations during the visual moisture and mold investigation

On Wednesday, August 13, 2009, we were contracted to investigate concerns about mold and moisture, expressed by the prospective purchasers at:
2718 Guilford Ave., Baltimore, MD 21218

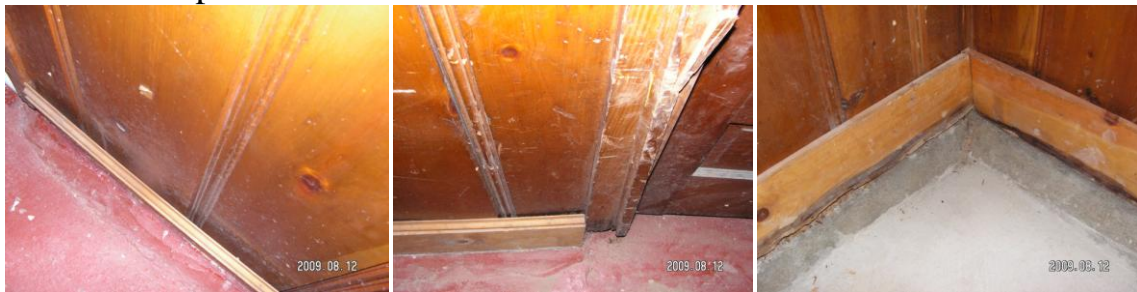
There is active and dormant mold growth on most of the visible walls in the basement. We identified the mold, on-site, as the humidity-condensation type, Aspergillus. There are a number of factors with this type of mold growth, including high humidity and condensation from temperature differential. The humidity measurement taken during the investigation exceeded 85%. This level will easily allow for mold growth. Review some of the pictures below and the white mold, which may look like dust, can be seen growing on the wall surfaces. As a point of reference, 1 in.² of Aspergillus mold can produce one million spores.

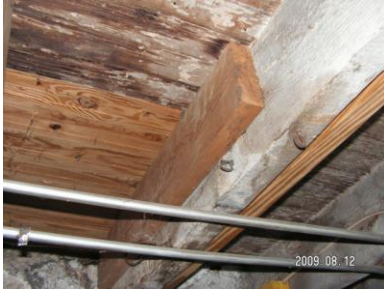
This same mold could be seen on the first floor joists.

2. Install at least one low temperature dehumidifiers, configured in a continuous operation mode to prevent the need for constant emptying of the condensation buckets. The relative humidity needs to be kept below 60%
3. Remove any building materials that touch the foundation walls since this is allowing moisture via capillary action.
4. Have a complete interior drain tile waterproofing system installed.
5. Have a qualified mason [repoint](http://video.about.com/homerepair/Tuck-pointing-basics.htm) the brick work along the front wall.
<http://video.about.com/homerepair/Tuck-pointing-basics.htm>
6. Consider a certified mold remediation contractor to clean or remove the building materials and to disinfect the floor joists.

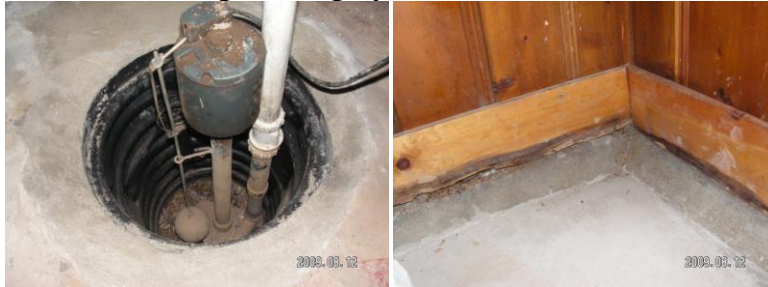
The finished portion of the basement has had a retrofit French drain, or trench drain, or waterproofing system, installed which terminates in the sump pit.

Unfortunately, this system is needed throughout the entire basement and especially along the front wall. The current system should be retrofit to include a full interior drain tile loop.

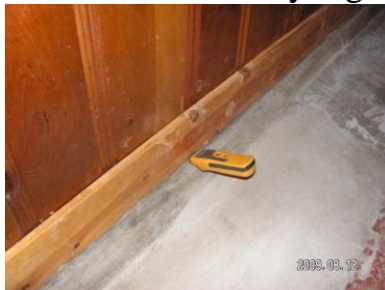
The finished basements building materials that are in contact with the concrete portion of this system are currently wet. When using a hand-held moisture meter, they registered full saturation.

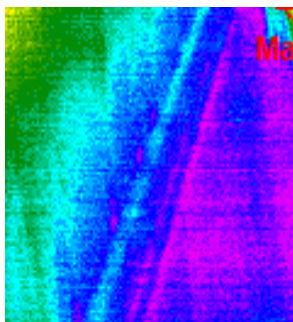
When examined with a thermal imaging camera, the blue areas are indicative of condensation which will allow mold to grow on the interior surface and behind the walls.

Basement walls should be insulated with non-water sensitive insulation that prevents interior air from contacting cold basement surfaces – the stone structural elements and the rim joist framing.
